Manhole Inspection Summary

Manhole # S4100_002MH

Insp Date: **2/21/07 1:57 PM**

Location Address: **2112 HARFORD RD**

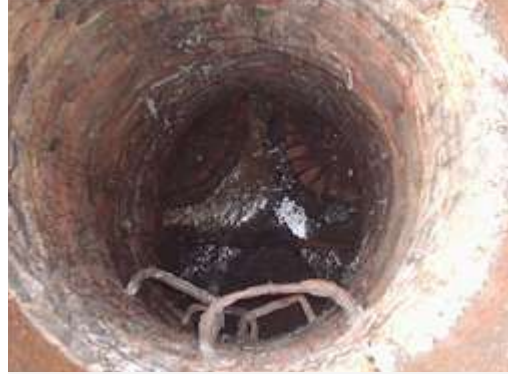
Top View

Corroded steps. Evidence of surcharge - Bench debris. Channel debris. Bench root intrusion.

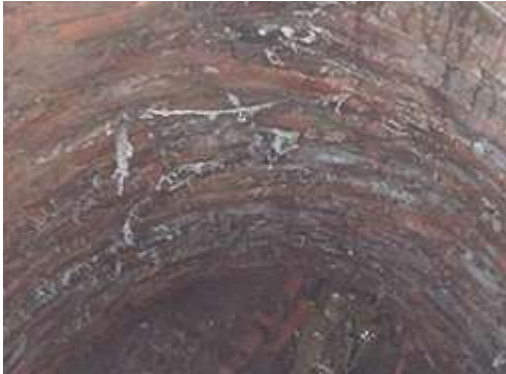
Defect

Barrel root intrusion and infiltration.

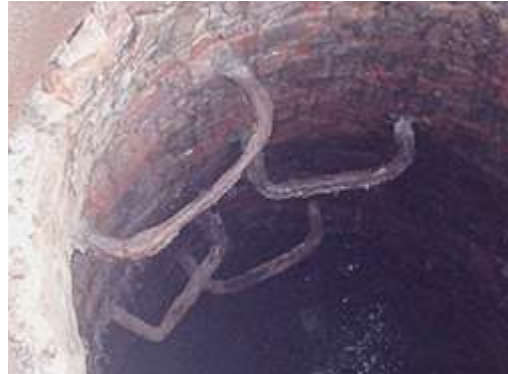
Defect

Frame leaks. Adjustment deterioration and infiltration. Corbel infiltration. Barrel root intrusion and infiltration.

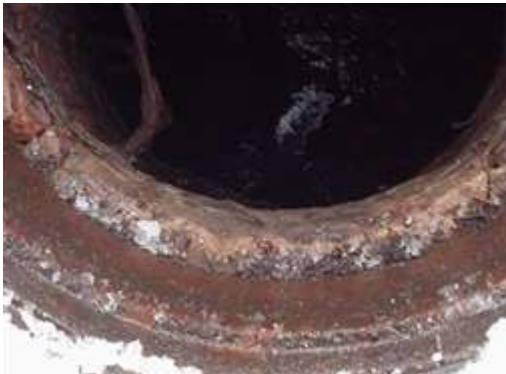
Defect

Frame leaks. Frame offset. Adjustment deterioration, root intrusion and infiltration.

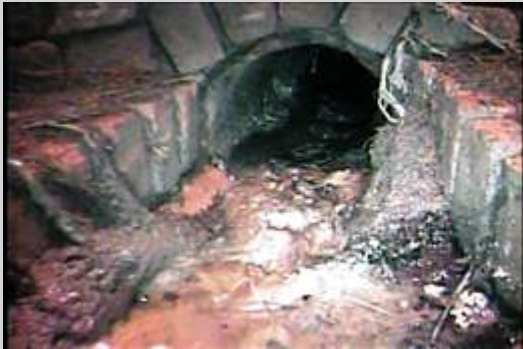
8 in. Circular Gravity Sewer Pipe Out @ 12 O'Clock

Barrel and Bench root intrusion. Channel deterioration, root intrusion and debris.

Deposits: ☐ None ☒ **Mud** ☐ Sludge ☒ **Debris** ☐ Grease

Infiltration: **Evidence** Pipe Seal Cond: **Roots**

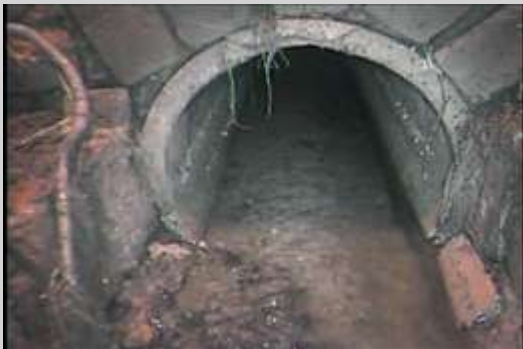
8 in. Circular Gravity Sewer Pipe In @ 3 O'Clock

Barrel deterioration, root intrusion and infiltration.

Infiltration: **None** Pipe Seal Cond: **Roots**

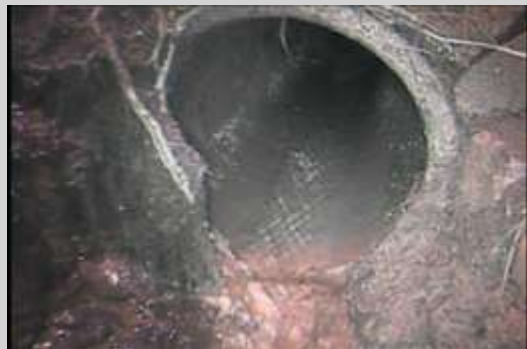
Pipe In @ 9 O'Clock

Barrel root intrusion.

Pipe Seal Cond: **Roots**
